Mobile Pentium® II Processor Specification Update

Release Date: October 1999

Order Number: 243887-014

The Mobile Pentium® II processor or the Intel® Pentium® II Processor Mobile Module may contain design defects or errors known as errata which may cause the product to deviate from published specifications. Current characterized errata are documented in this Specification Update.

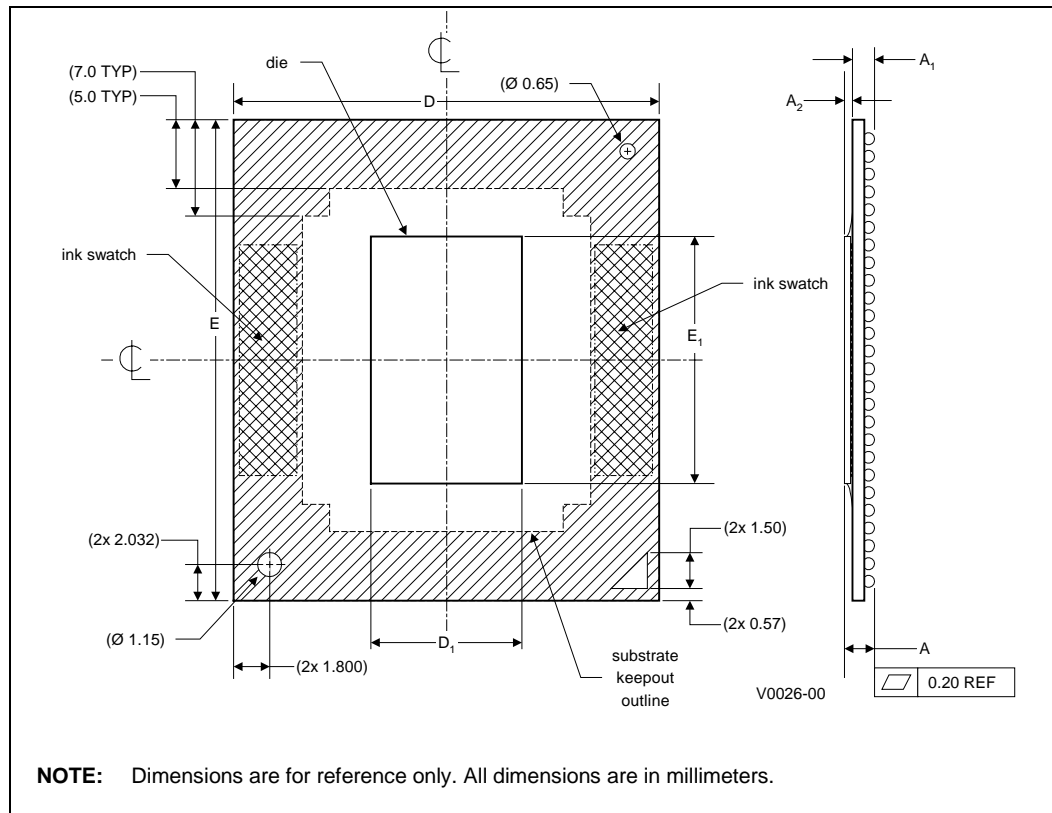
Figure 5.3. Surface-Mount BGA1 Package—Top and Side View

The following table and figures show the updated mechanical specifications for the BGA1 package, listed as Table 5.2, Figure 5.3 and Figure 5.4, respectively, in the *Mobile Pentium® II Processor in BGA Package at 366 MHz, 333 MHz, 300PE MHz, and 266PE MHz* datasheet.

1. The number shown here is different from that in the 243887-010 revision of this specification update. The maximum reference number is used.
